**RAILWAY INVESTIGATION REPORT**  
**R99W0231**

**DERAILMENT AND COLLISION**

**CANADIAN PACIFIC RAILWAY**  
**TRAIN 472-30 AND TRAIN 471-30**  
**MILE 42.4, CARBERRY SUBDIVISION**  
**NEAR POPLAR POINT, MANITOBA**  
**01 NOVEMBER 1999**

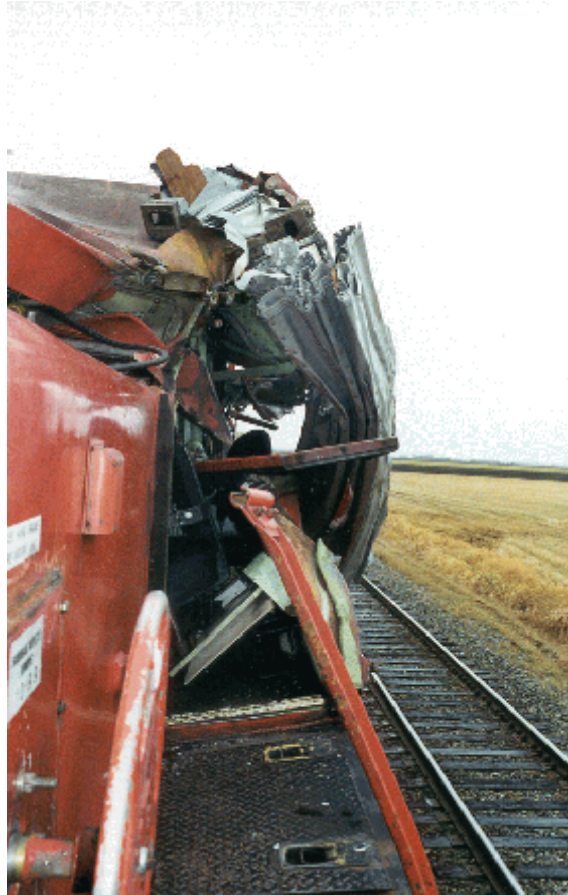
The three SD-40-2 locomotives on train 472 sustained extensive damage. However, the locomotives did not derail. The conductor's side of the lead locomotive on train 472, CP 5921, was raked open and the metal skin peeled back the length of the locomotive cab. The locomotive windshield and side windows were broken and the locomotive cab roof was buckled inward. The front door on the conductor's side was catapulted into the conductor's seat (see Figure 1).

Figure 1 - Damage to the lead locomotive on train 472

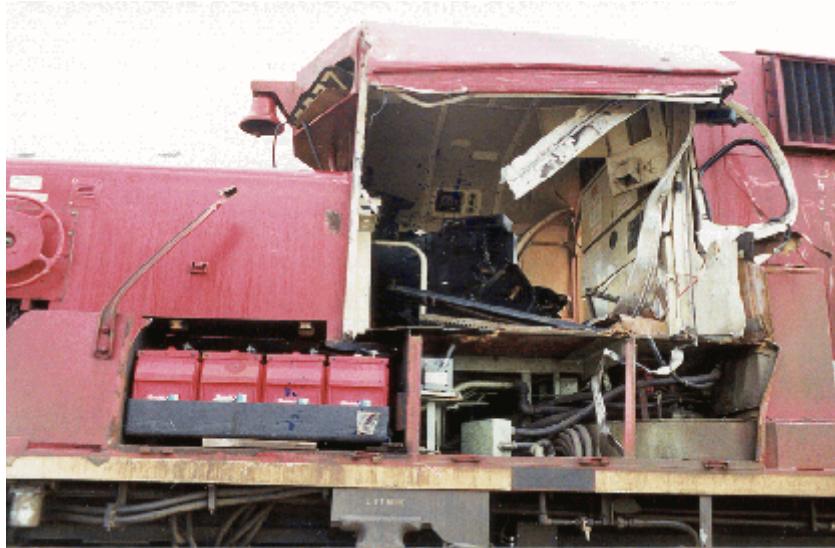
The second locomotive on train 472, CP 5877, was similarly raked open on the conductor's side and the metal skin peeled back exposing the locomotive batteries and the interior of the locomotive cab (see Figure 2). The conductor's seat was torn from its mount and was located approximately 400 feet away from the locomotive, laying on the ballast between the two main tracks.

Figure 2 - Damage to the second locomotive on train 472

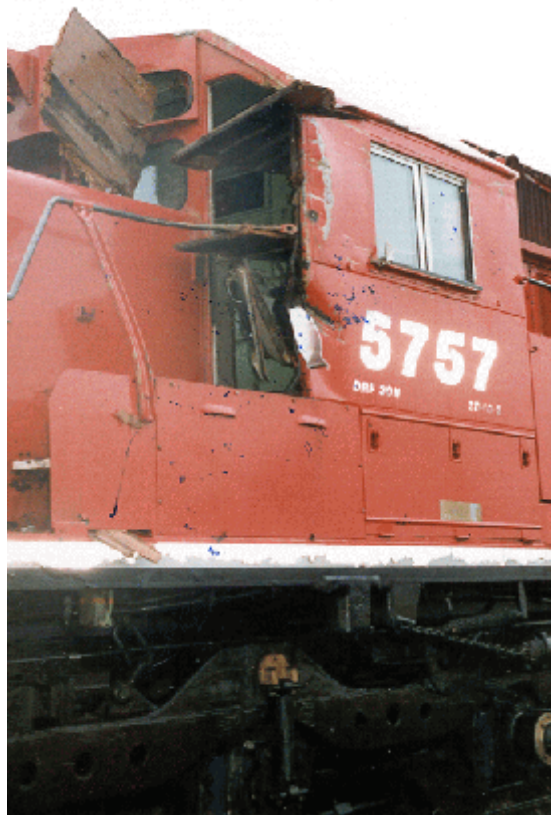
The cab of the third locomotive on train 472, CP 5757, was penetrated through the windshield and conductor's side door by large, splintered pieces of plywood from containers that were breaking up at the time of contact with the third locomotive (see Figure 3).

Figure 3 - Damage to the third locomotive on train 472
